TITLE: MSD Frederick Campus Dormitories, Student Center, and Satellite Student Health Center

MARYLAND SCHOOL FOR THE DEAF FREDERICK CAMPUS

Dormitories, Student Center & Satellite Student Health Center

Part I & II Programs

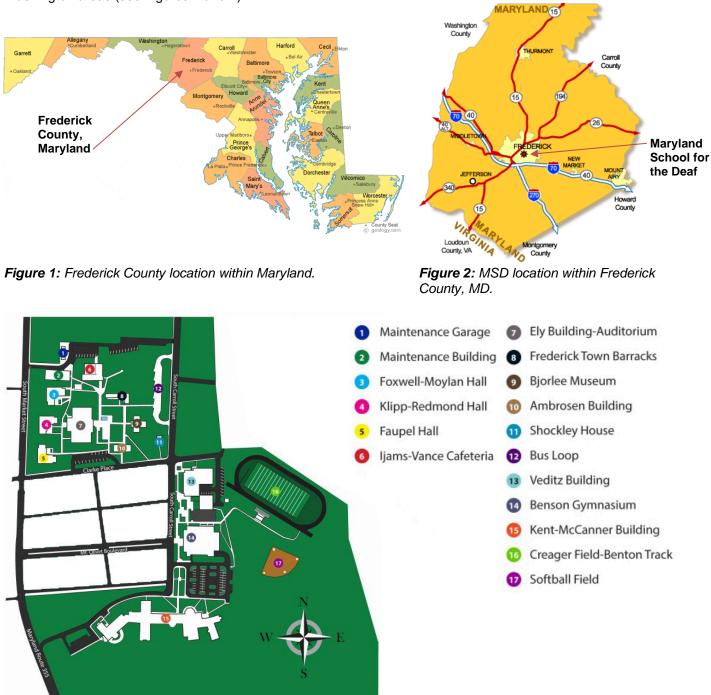
Figure 3: MSD campus map.

The Frederick campus is made-up of several parcels of land acquired for the school over many years and is therefore not a single contiguous property (see Figures 3 and 4). The campus has three major sections: the original main campus, located on the northwest corner of Clarke Place and South Carroll Street; the Veditz Vocational Building/Benson Gymnasium complex, which includes the football and recreational fields, located on the southeast corner of Clarke and South Carroll; and the Loats Farm parcel, location of the Elementary and Family Education Complex.

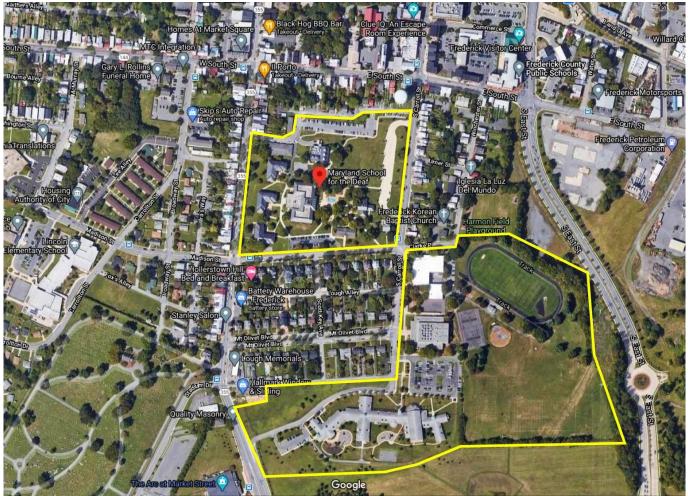
Figure 4: MSD adjacencies map with the campus parcels outlined in yellow.

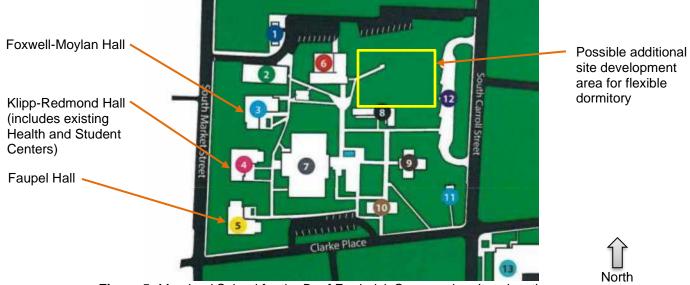
Figure 5: Maryland School for the Deaf Frederick Campus dormitory location map.

The dormitory buildings at the Maryland School for the Deaf Frederick Campus – Foxwell-Moylan, Faupel, and Klipp-Redmond Halls – are at the west side of campus, situated along S. Market Street near its intersection with Clarke Place (see Figure 5 below). All three were constructed in the mid-1960s with similar designs that resulted in the buildings being nearly identical in appearance, layout, construction techniques, fixtures, and finishes. These are the facilities under consideration for physical improvements with this project and their sites are under consideration for use for improved or new buildings, as is an undeveloped area of the campus at its northeast corner (highlighted in yellow on the map below). In accordance with the MSD Frederick Campus 2016-2030 master plan, exploration of the option to demolish Klipp-Redmond Hall and to establish its site as an outdoor open space with visibility of the Ely Building from Market Street is part of the proposal for this programming effort.

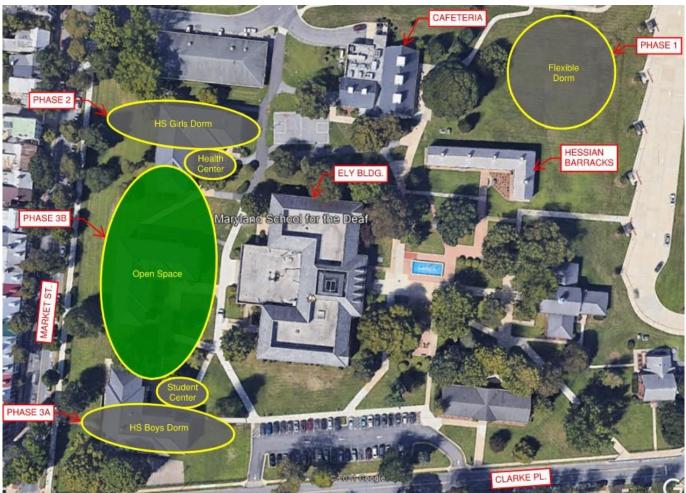
Figure 6: Maryland School for the Deaf proposed campus plan at completion of dormitory replacements.

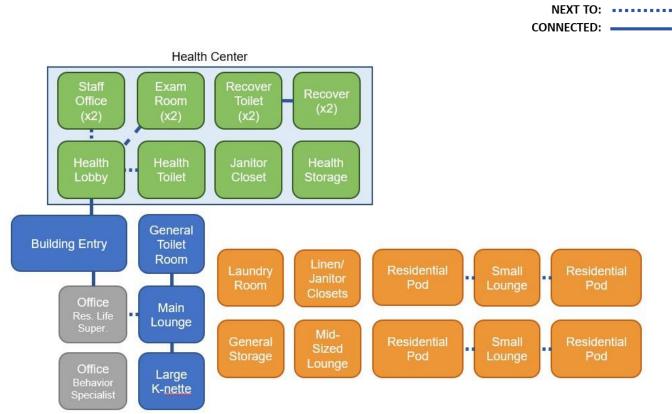
Figure 13: Girls Dormitory Space Bubble Diagram – Entry Level

Figure 14: Girls Dormitory Space Bubble Diagram – Upper Level

The Girls Dormitory will also house the Satellite Student Health Center. This will be a suite of spaces with a lobby and waiting area, staff offices, a general use accessible toilet room, a janitor closet, storage room, two exam rooms, and two recovery rooms with private accessible toilet rooms. As with the entire dormitory replacement project, all rooms and spaces of the Health Center should be designed to comply with ADA and DeafSpace guidelines. The Health Center lobby will be connected to and have visibility to the main building entry lobby. In addition, it will have a separate entrance directly from the exterior for daytime use. Two staff offices will be next to and have visibility of the Health Center lobby and waiting room for supervision. The Health Center will have an additional exit so that students entering the waiting area can be kept guarantined from those who have completed their treatment. There will be two recovery rooms with private full accessible bathrooms. These will be designed for beds so that students can stay overnight for observation or guarantine.

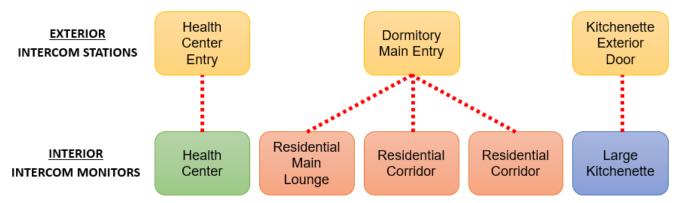
Figure 17: Bubble diagram depicting the typical video intercom system to be provided for the dormitory buildings.

A video intercom system will be provided (refer to Figure 17, next page). All video intercom stations will have voice and video. It is critical that the video allows a person at each station to communicate via sign language. The intercom station should also have a visual device to indicate when a call is being received. Whenever a call is

An outdoor intercom station will be provided outside the main entry of each building. The intercom will allow a person at the entry to communicate with at least three indoor intercom stations, or one indoor intercom station per floor, whichever is greater. The main entry intercom will simultaneously call all indoor intercom stations. The first person inside the building to respond to the call will be able to communicate with to the person outside the main entry and decide whether or not to unlock the door.

Additional intercom stations will be provided outside the entry to the Health Center connected to a dedicated indoor intercom station inside Health Center and outside the main kitchenette for each building with a dedicated indoor intercom station inside the kitchenette exterior door. The latter will allow for ease of food deliveries, which would not have to go through the main entry.

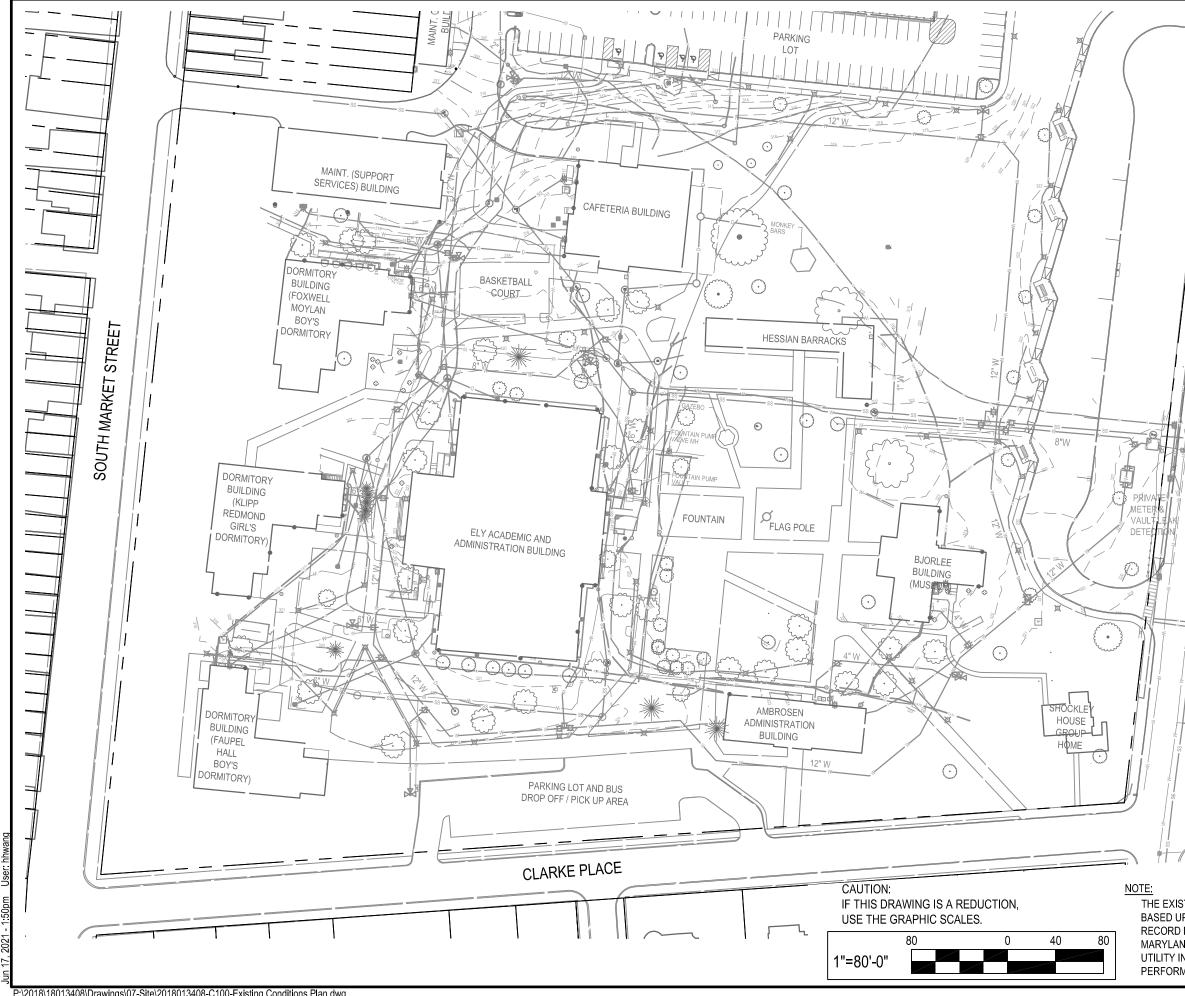
EXISTING SITE AND UTILITY PLAN

PARKING	DATE: 06/17/2021	SCALE: 1"=80'	C-1
		EXISTING CONDITIONS PLAN	MARYLAND SCHOOL FOR THE DEAF	FREDERICK CAMPUS 101 CLARKE PLACE FREDERICK, MARYLAND 21701
	MAJOR CONTOUR 500 MINOR CONTOUR - - CONC. CURB - CONC. PAD/WALK - PROPERTY LINE - U/G TELEVISION LINE CATV U/G GAS U/G SANITARY SS U/G WATER W	WHITNEY BAILEY COX & MAGNANI, LLC 300 East Joppa Road Suite 200 Baitmore, MD 21286		Designing Infrastructure for Tomorrow [®]
THE EXISTING CONE BASED UPON AVAIL RECORD DOCUMEN MARYLAND SCHOOL UTILITY INVESTIGAT	DITIONS INFORMATION SHOWN HEREIN IS ABLE GIS INFORMATION AND EXISTING T PROVIDED BY MARYLAND DGS AND THE . FOR THE DEAF. NO FIELD SURVEYS, IONS, OR FIELD MEASUREMENTS WERE RT OF THIS EXISTING CONDITIONS MAPPING.			Designing Int

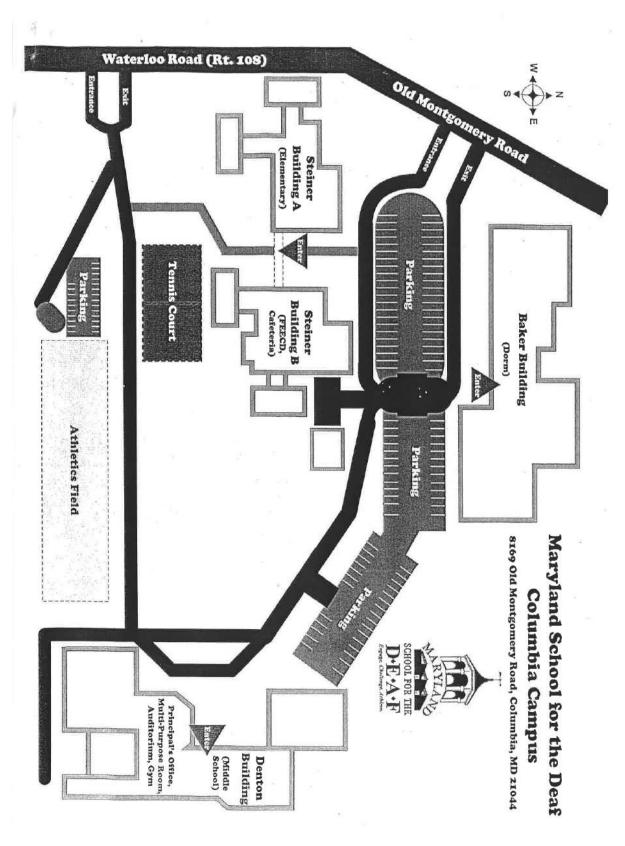
Figure 3 Columbia Campus Existing Site Plan

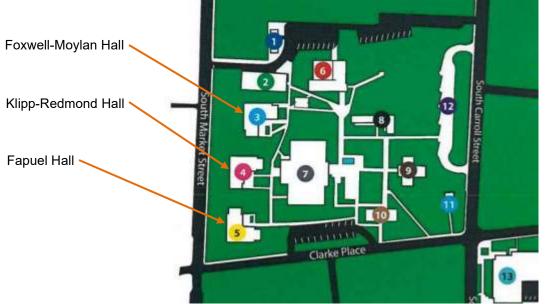
Maryland School for the Deaf Frederick Campus dormitory location map.

The Maryland School for the Deaf Frederick Campus has three dormitory buildings at west side of campus – Foxwell-Moylan, Fapuel, and Klipp-Redmond Halls. They are situated along S. Market Street, near its intersection with Clarke Place (see map below). All three were constructed in the mid-1960s with similar designs that resulted in the buildings being nearly identical in appearance, layout, construction techniques, fixtures, and finishes. This assessment is part of a programming effort being undertaken by the Maryland Department of General Services that will result in a construction project to renovate or replace the three existing buildings.

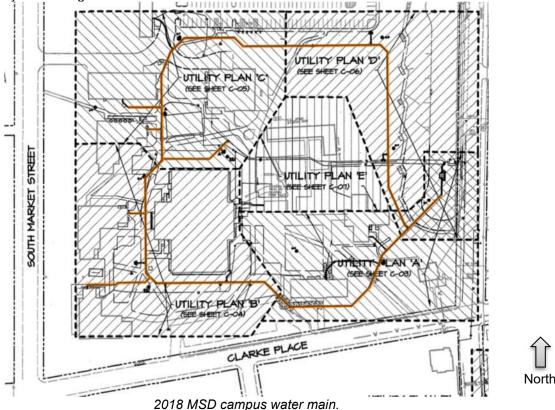
The MSD campus underwent a campus wide wain main replacement project that completed construction in 2018 (see map below). That project included a new 12-inch water main campus loop and new 6-inch service connection to the Foxwell-Moylan building.

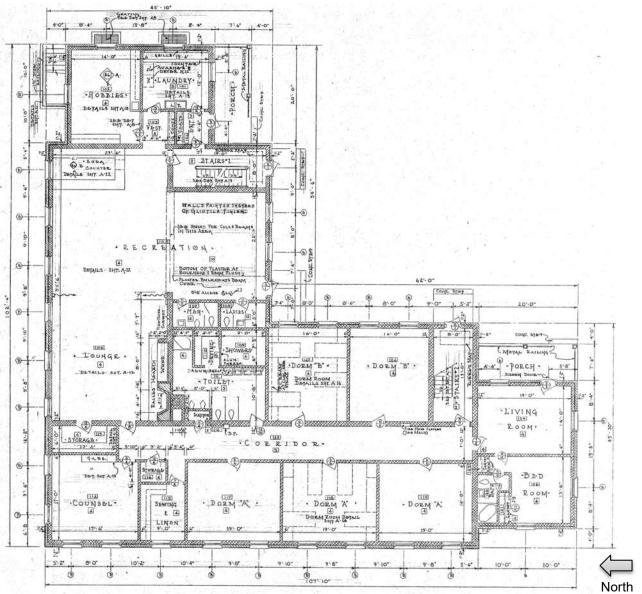
Foxwell-Moylan Hall first floor plan.

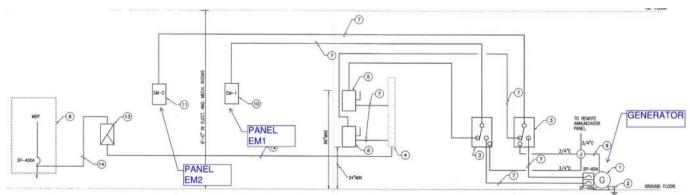
Figure 21: Emergency power riser diagram.

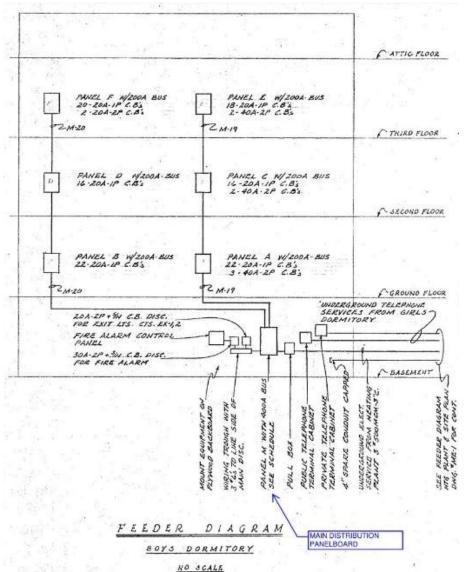
Figure 30: Normal power riser diagram.

The building is powered by a 120/240V, 1 phase, 3 wire, 400A main circuit breaker main distribution panelboard (see Figures 17 and 30), located in the mechanical room at the basement of the building. Based on the date on the electrical inspection sticker (see Figure 18), it appears that the panelboard was installed in the 1960s.

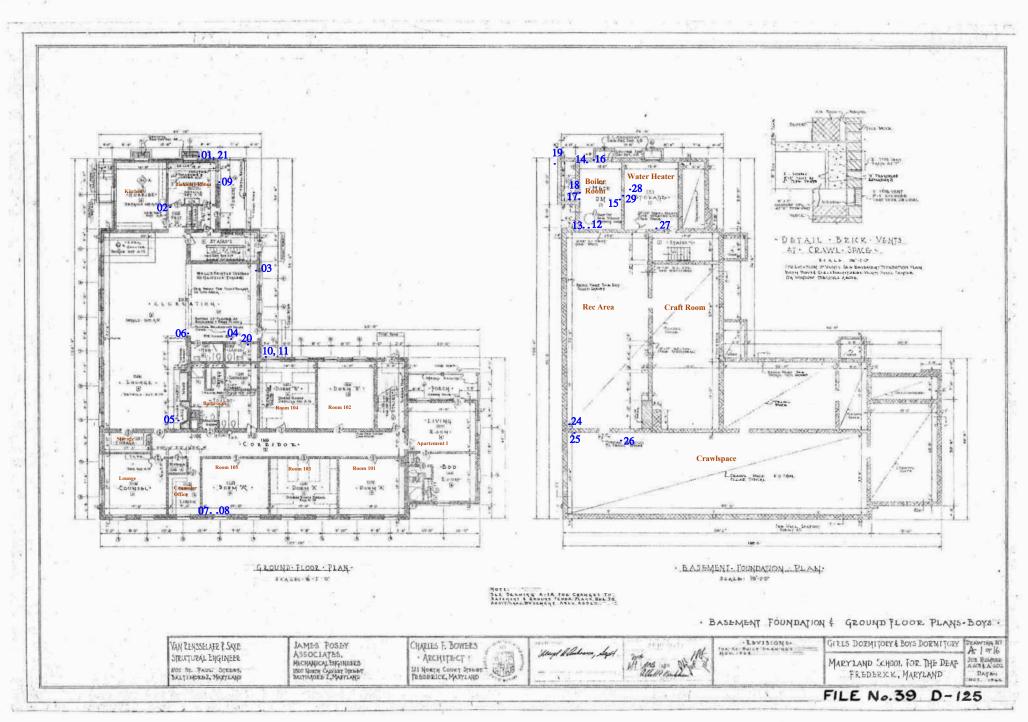
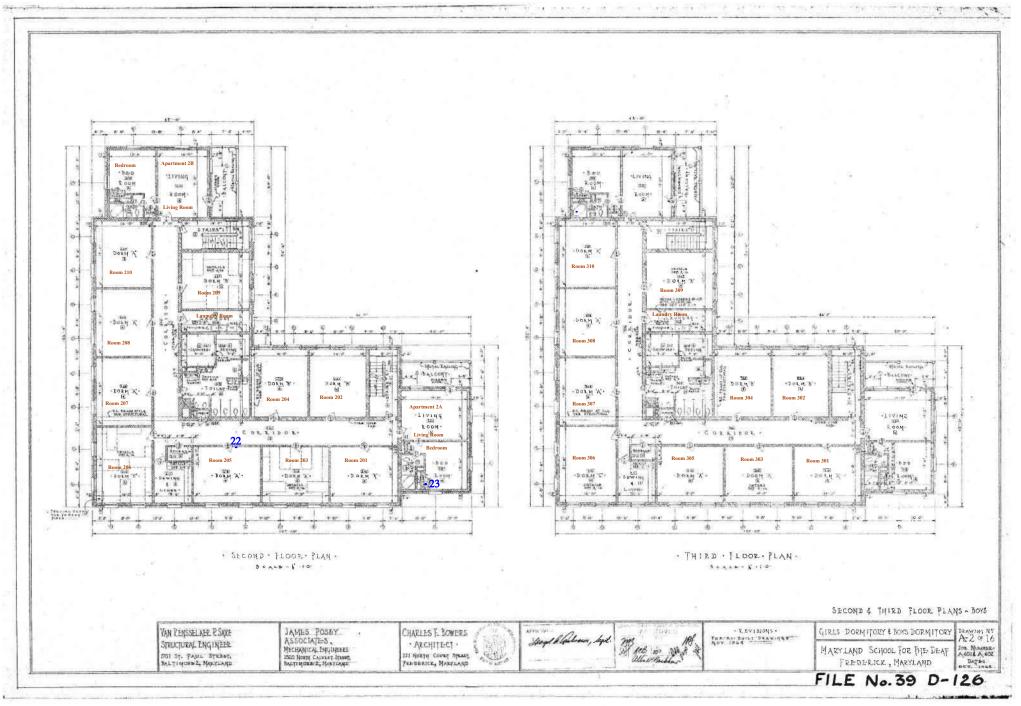
Asbestos Sample Location Plan
